BIRD STRIKE CAPABILITIES OF TRANSPARENT AIRCRAFT
WINDSHIELD MATERIALS. PART II. SUPPLEMENTAL
EVALUATION OF PARAMETERS AFFECTING MATERIALS RESPONSE

Goodyear Aerospace Corporation

AFML-TR-74-234
Part II

Part II. Supplemental Evaluation of Parameters Affecting Materials Response

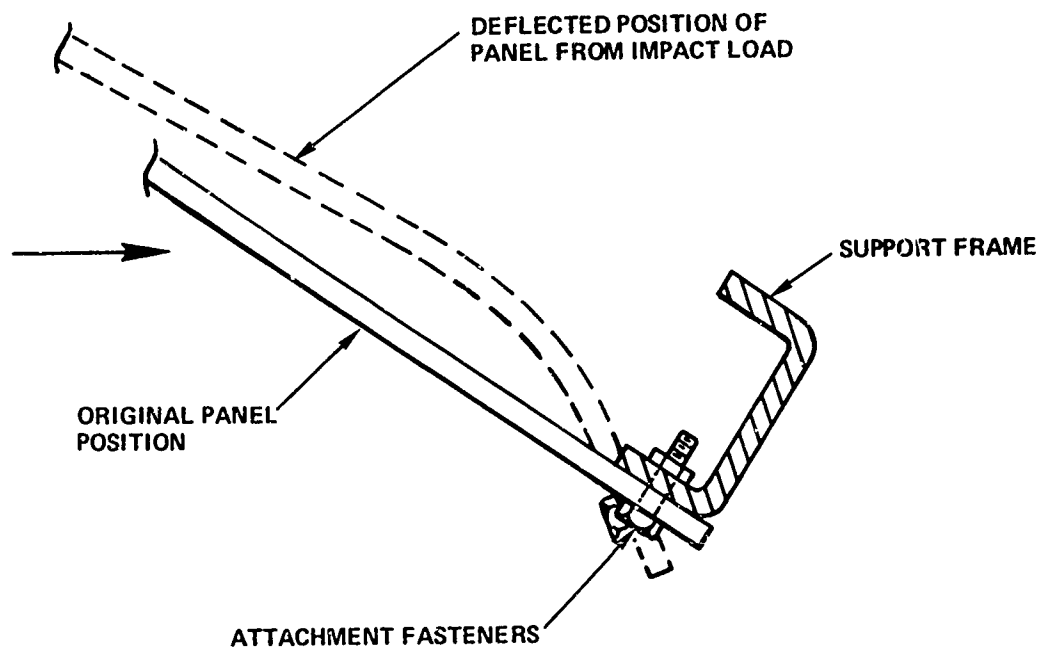
A possible explanation for the effect of the fastener size on penetration velocity can be seen by referring to Figure 27. This diagram represents a cross section through the lower edge of the test panel and its support frame. When the panel is attached with the large 0.50-in. -diameter fasteners, very slight, if any, rotation of the clamped edge of the panel is permitted by the clamping action of the bolts. In addition, the higher bending stiffness of the 0.50-in. bolts limits their bending deflection so that pocketing of the panel causes high tensile, shear, and bending loads in the panel along the lower edge of the frame. With the smaller diameter fasteners such as the 0.25-in. bolts, more edge rotation is possible, as shown in Figure 27. Typically, the high loads caused some shear failures in the threads of the fastener, permitting the panel edge to lift up. Also, the lowered bending stiffness of the fasteners

Figure 27. Action of Lower Edge of Test Panel During Bird Impact Loading

permitted more bolt deflection, and the smaller-diameter fasteners at closer spacings provided more uniform edge load distribution. The overall effect is to lower the local concentrated loads in the panel along the edge of the frame.
